Lovejoy® Presents Rock Solid Solutions For Granite Construction

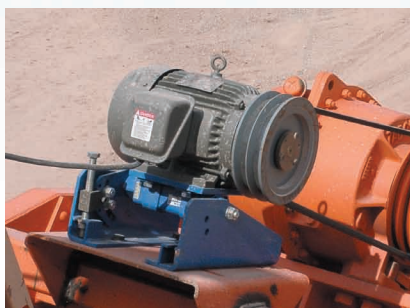
ROSTA MB 50 x 200 Motorbase

The area Sales Engineer for Lovejoy, Inc. -- the country's leading company dedicated to the design and production of couplings and engineered power-transmission solutions -- met with Mr. Guerrero to assess the situation. What Lovejoy recommended was replacement of their shaker's failure-prone motorbase with a Lovejoy® ROSTA® MB 50 x 200

motorbase. This would keep a proper tension on the V-belts during start-up and under high-load conditions. Unlike a conventional motorbase, the Lovejoy ROSTA MB 50

x 200 utilizes an elastomeric torsion element as a pivot mount. This unique design allows the Lovejoy ROSTA MB 50 x 200 motorbase to continuously compensate for normal V-belt wear. This also eliminates V-belt slippage and rollover -- problems that Granite Construction was experiencing with their conventional motorbase.
